**Flood Control Project Maintenance
Levee Inspections**

Fall 2016 Levee Maintenance Deficiency Summary Report

Sacramento River Basin

| RD0150 | Overall LMA Rating | Total LMA Miles | * Overall LMA Threshold Percent is less than 10.00%; however, U Rated Miles are present, so the Overall LMA Rating is M instead of A. | | | | | |
|--|---|---|---|---|---|---|---|---|
| Reclamation District No. 0150 Merrit Island | M * | 17.74 | | | | | | |

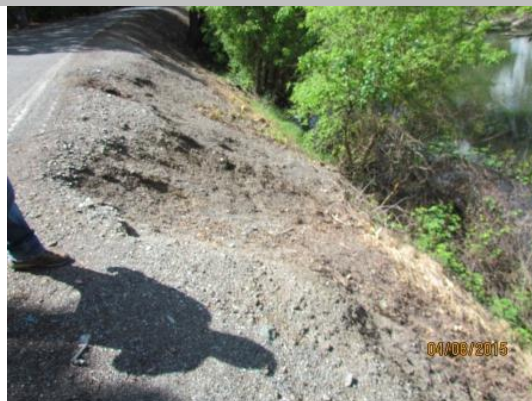
Photo 1 of 2 : FA_2016_RD0150_17_61_20160823_00054.jpg

Updated picture of the erosion on the waterside of the levee during spring 2015 inspection.

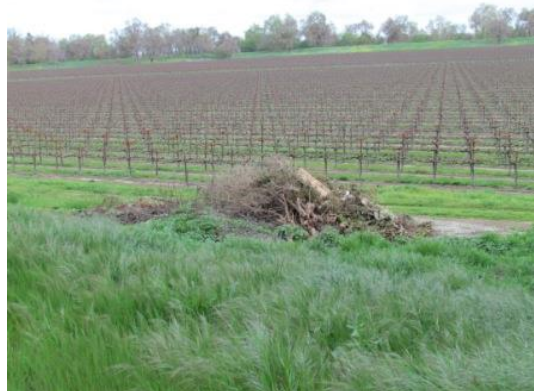
Photo 1 of 2 : FA_2016_RD0150_17_935_20160823_00099.jpg

Prunings were found on the landside of the levee looking upstream.

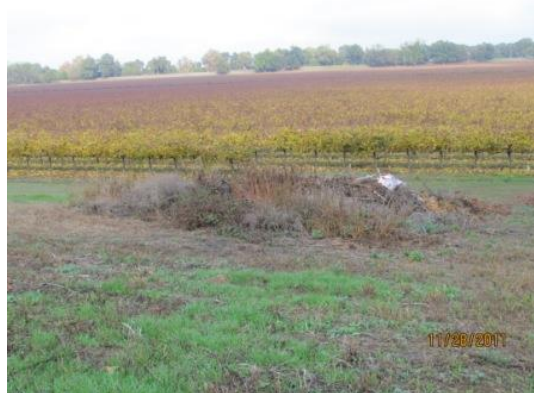
Photo 2 of 2 : FA_2016_RD0150_17_935_20160823_00100.jpg

Prunings were found on the landside of the levee looking upstream. This picture was taken during fall 2011 inspection.

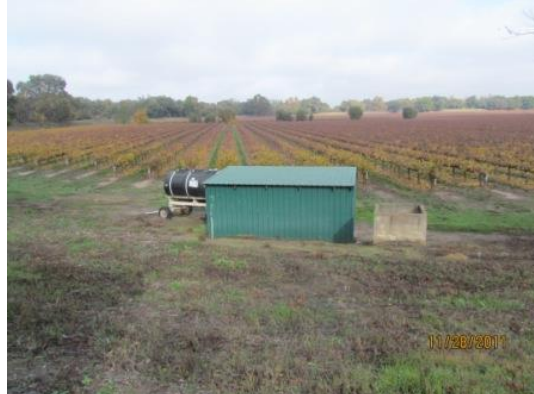
Photo 1 of 1 : FA_2016_RD0150_17_16_20160823_00014.jpg

Equipment and buiding was found on the landside of the levee looking upstream.

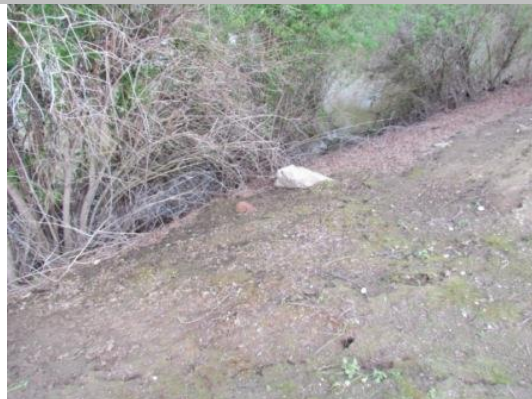
Photo 1 of 1 : FA_2016_RD0150_17_87_20160823_00080.jpg

| A concrete or anchor block was found on the slope of the levee. | | | | | |

A concrete block was found on the waterside of the levee looking upstream.

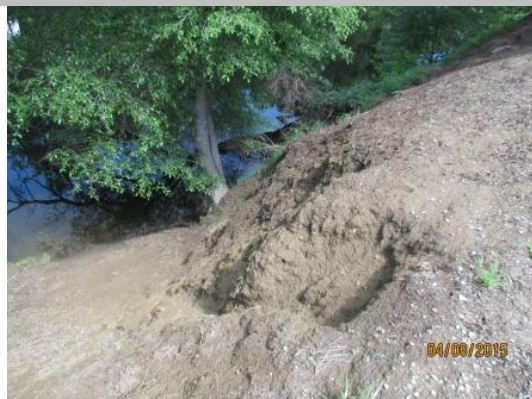
Photo 1 of 2 : FA_2016_RD0150_17_92_20160823_00084.jpg

Updated picture of the slope instability on the waterside of the levee looking upstream during spring 2015 inspection.

| S1 : Repair slope instability. | | | | | |

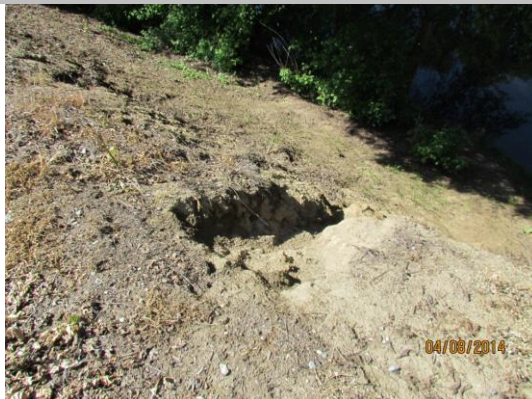
Photo 2 of 2 : FA_2016_RD0150_17_92_20160823_00085.jpg

A slope instability was found on the waterside of the levee looking downstream.

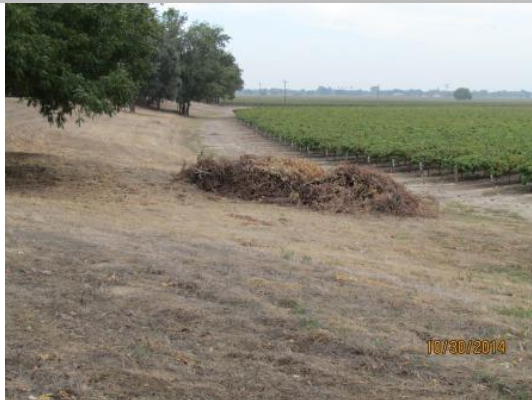
Photo 1 of 1 : FA_2016_RD0150_17_82_20160823_00075.jpg

Prunings were found on the landside toe of the levee looking upstream.

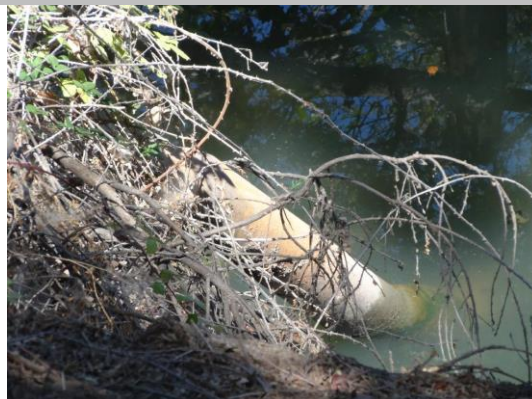
Photo 1 of 2 : UCIP_FA_2016_50670_33627.jpg

| FIELD_STRUCT_DESC: *ABANDONED* 10-inch steel irrigation pipe through the levee, 13.8 feet below the crown. Gate valve on the waterside (WS) slope. Pilings in water but no pump found. Service pole with guy wire on the landside (LS) slope. Standpipe on LS slope. | | | | | | |

WS view: pipe visible on levee slope and in the stream.

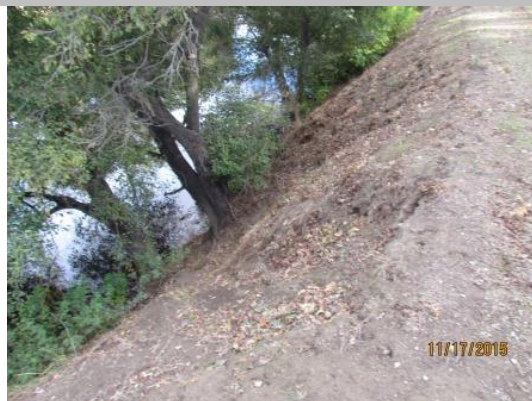
Photo 1 of 1 : FA_2016_RD0150_17_65_20160823_00060.jpg

View of erosion on the waterside of the levee.

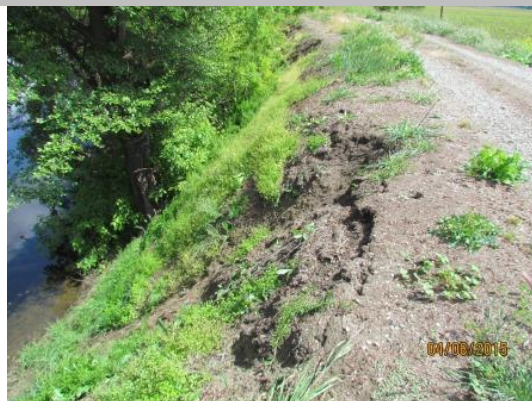
Photo 1 of 1 : FA_2016_RD0150_17_66_20160823_00061.jpg

Updated picture of the erosion on the waterside of the levee.

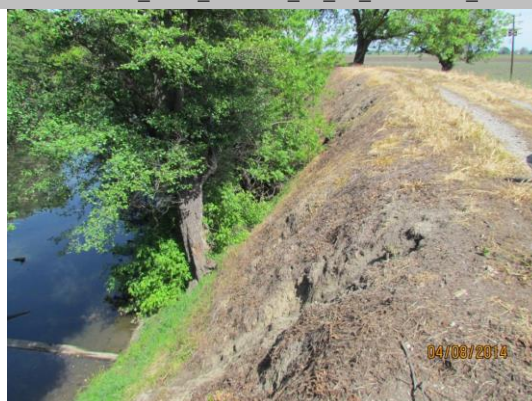
Photo 1 of 2 : FA_2016_RD0150_17_67_20160823_00062.jpg

Updated picture of the erosion on the waterside shoulder looking upstream during spring 2014 inspection.

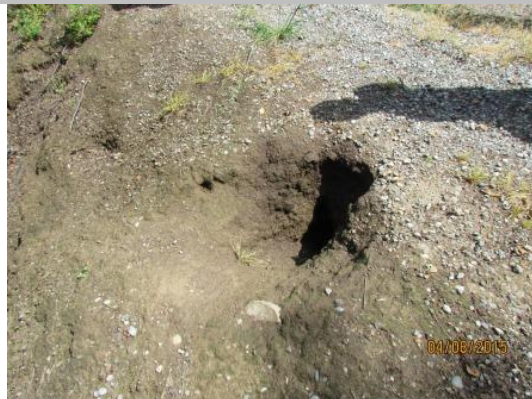
Photo 1 of 2 : FA_2016_RD0150_17_89_20160823_00081.jpg

Updated picture of a rodent hole on the waterside shoulder of the levee during spring 2015 inspection.

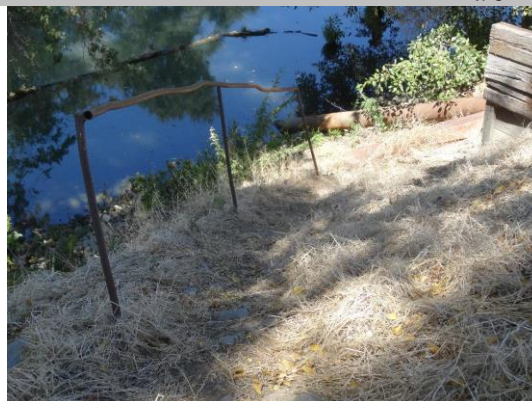
Photo 1 of 2 : UCIP_FA_2016_41648_33642.jpg

| FS_ID:41648 DS_ID:22467 EP_NO: N/A Repair Type: Non-Urgent Crossing Status: Found UCIP Comments: - walkway in poor functional condition- an abandoned 8-inch steel pipe next to 12" pipe. This 8" pipe might have merged with 12" pipe under the levee .- Pipe and pump inside concrete masonry wall. FIELD_STRUCT_DESC: 12-inch steel pipe through the levee, 13.0 feet below the crown, pump and gate valve in pump house on the waterward slope. Concrete distribution box at the landward toe. Service pole on the waterward shoulder. O&M Manual SAC 112, March 1957. FS Date: 8/23/2013 | | | | | |

WS view: walkway and inlet pipe on levee slope.

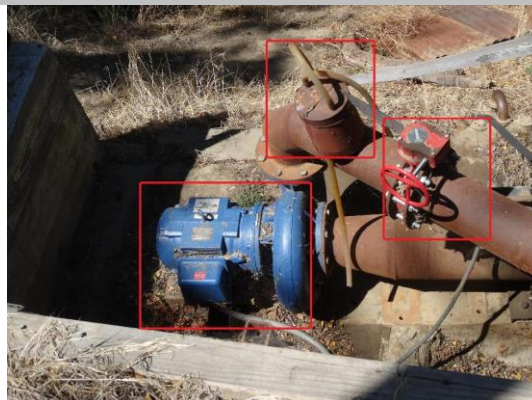
Photo 2 of 2 : UCIP_FA_2016_41648_33641.jpg

WS view: pump, gate valve, and airvent on pipe inside concrete masonry box.
